The Solar-Powered **WASTE RECLAMATOR**

Chris Laughton

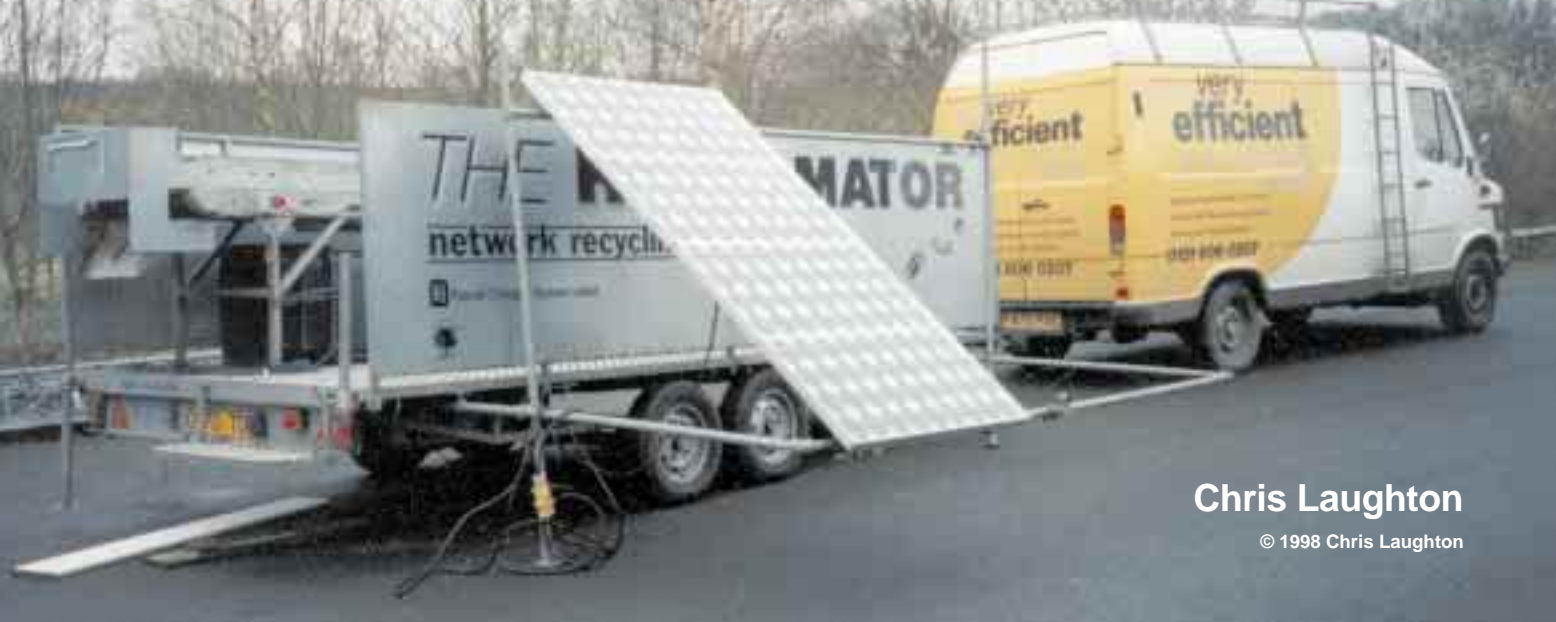
Above: The Reclamator with one of its three PV arrays in place.

At this stage BP Solar generously donated twelve BP160 65 Watt framed modules, which seemed like the maximum number for a movable array. To ease the constant re-making of the array at each site, sets of four modules were bolted to 50 mm (2 inch) aluminum U-channel. We had three sections in all, each weighing 35 kg (77 pounds) just light enough for one person to lift.

The weight of arrays was taken by the trailer bed, using galvanized 40 mm (1.6 inch) steel tube. The removable subarrays pivot to allow angle adjustment at each site.

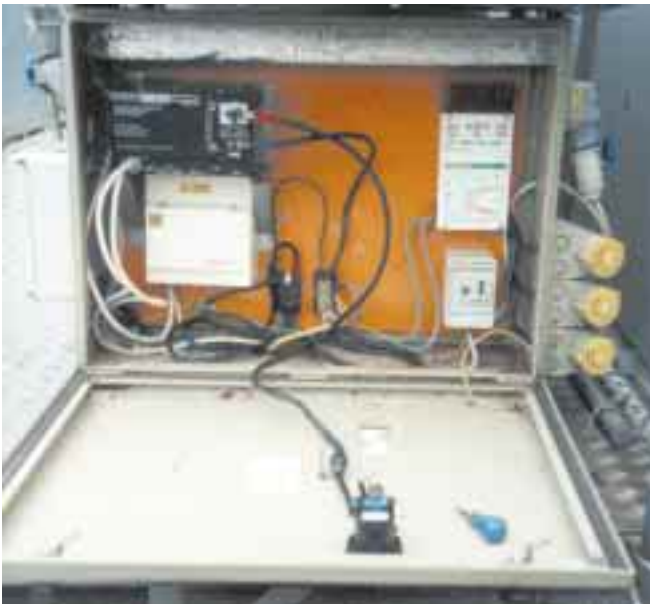
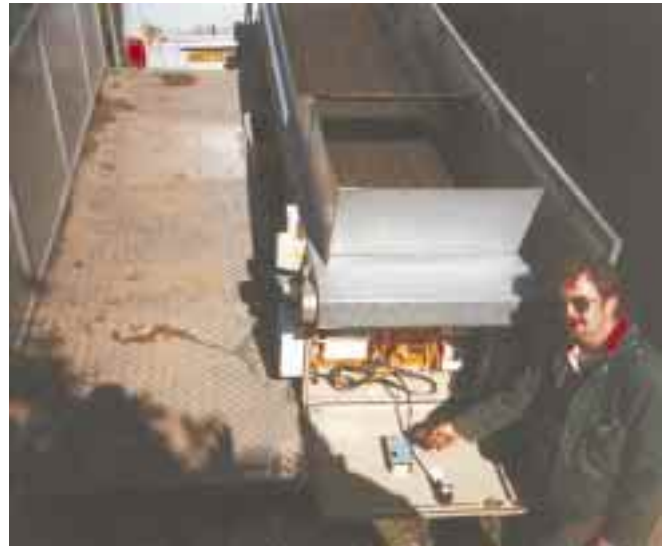
Below: The Reclamator power panel showing inverter, charge controller, AC breaker and MCB, and shunt.

The back of the E-Meter can be seen in the folded down door. At right are the three plugs for the PVs.

Above: The feed end of the conveyor belt. Phil Evans shows the inside of the opened power panel.

This battery layout worked well for the 24 Volt system voltage (resulting in a total 100 AH capacity to 50% discharge). It also suited the PVs and the choice of a Trace 624/SB/E for the inverter/charger. A Trace C40 served as the PV charge regulator and an E-meter was used for monitoring the system. The harsh environment dictated a high-integrity lockable IP65 steel cabinet for this equipment. Two pull-out T-class fuses (50 Amp and 100 Amp respectively for the PV array and battery) were bolted to the sides of this as emergency disconnects. Three yellow 32 Amp CE22 sockets to plug in the arrays and a blue 16 Amp CE22 socket for mains battery charging were bolted to the other side. Finally another blue socket was externally mounted as the 230 vac inverter output, via internal 5 amp RCDs.

The battery cables came into the bottom of the cabinet through steel bushings penetrating both the cabinet and trailer chassis. We were concerned about the possible heat build-up in such a sealed cabinet, but the large

metal surfaces were likely to dissipate the heat. The Trace inverter was given extra lower supports to protect it from road vibration. It may be worth noting that here in Europe, a gradual harmonization of voltages is taking place such that the UK 240 vac is being lowered to 230 vac, so this E version of the Trace is set at the lower voltage.
